**AREA B - EAST/WEST STREETS
EXISTING LIGHT LEVELS VERSUS
PROPOSED CRITERIA**

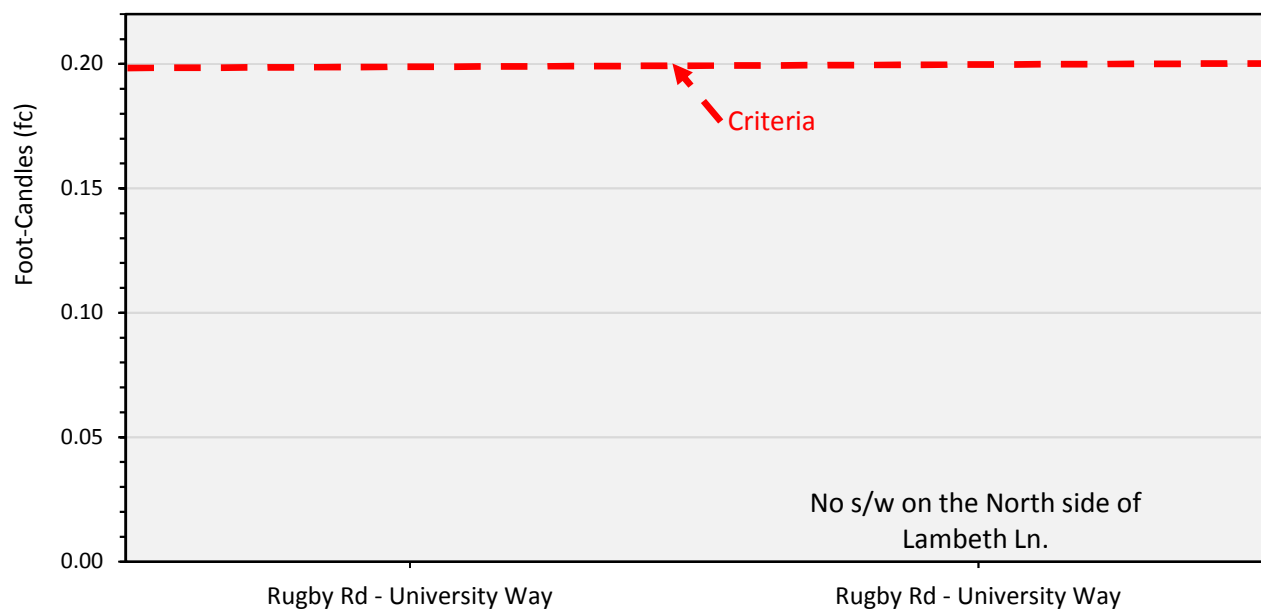
Lambeth Ln - Eastbound Min. Vertical Illuminance from Existing Lighting

Lambeth Ln

Sidewalk Width: 4ft

Adjacent Land Use: Residential

Functional Classification: Local

Pedestrian Activity: High

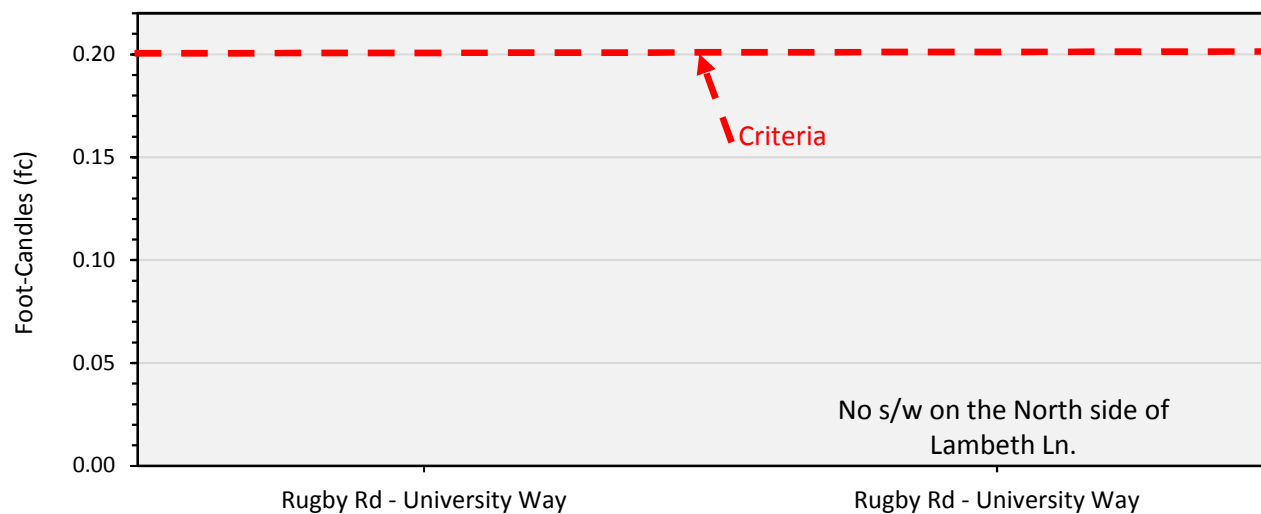
Lambeth Ln - Westbound Min. Vertical Illuminance from Existing Lighting

1. Where no bar is shown, minimum vertical value of 0.00 fc was recorded.

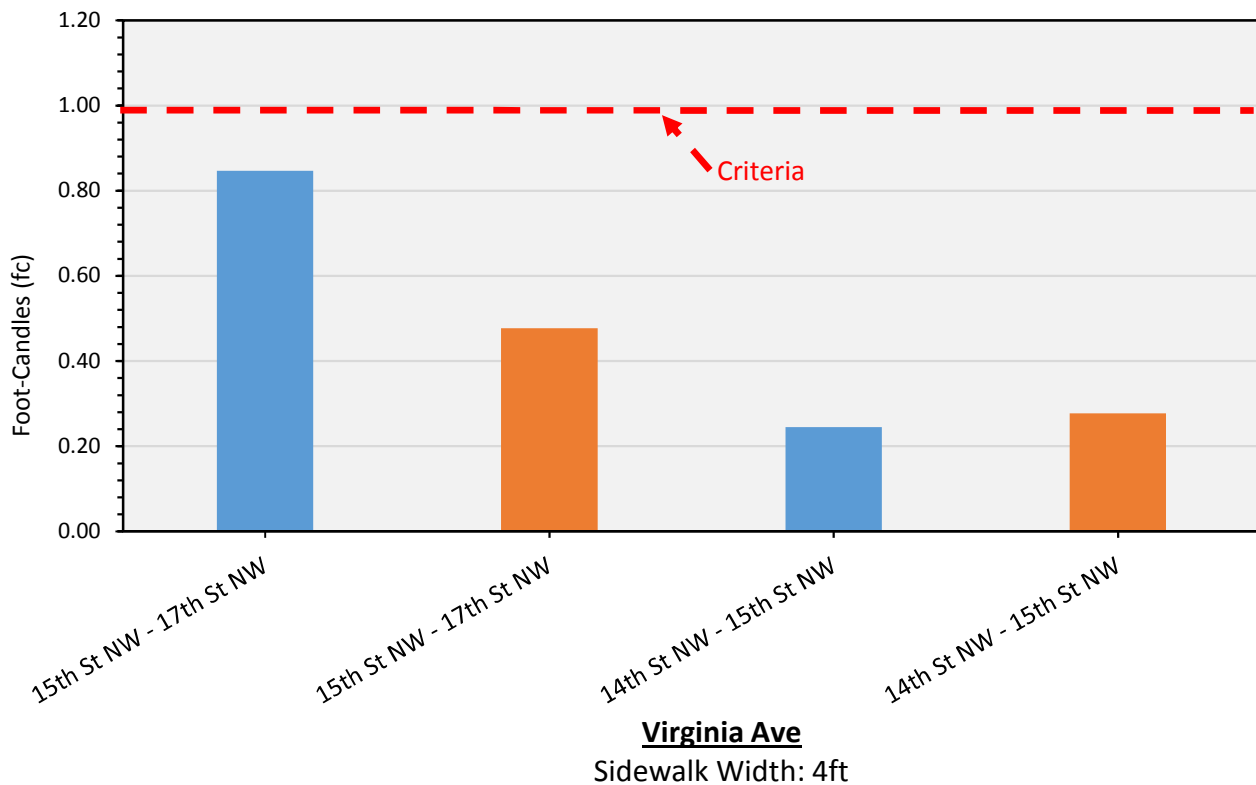
Virginia Ave - Average Illuminance from Existing Lighting

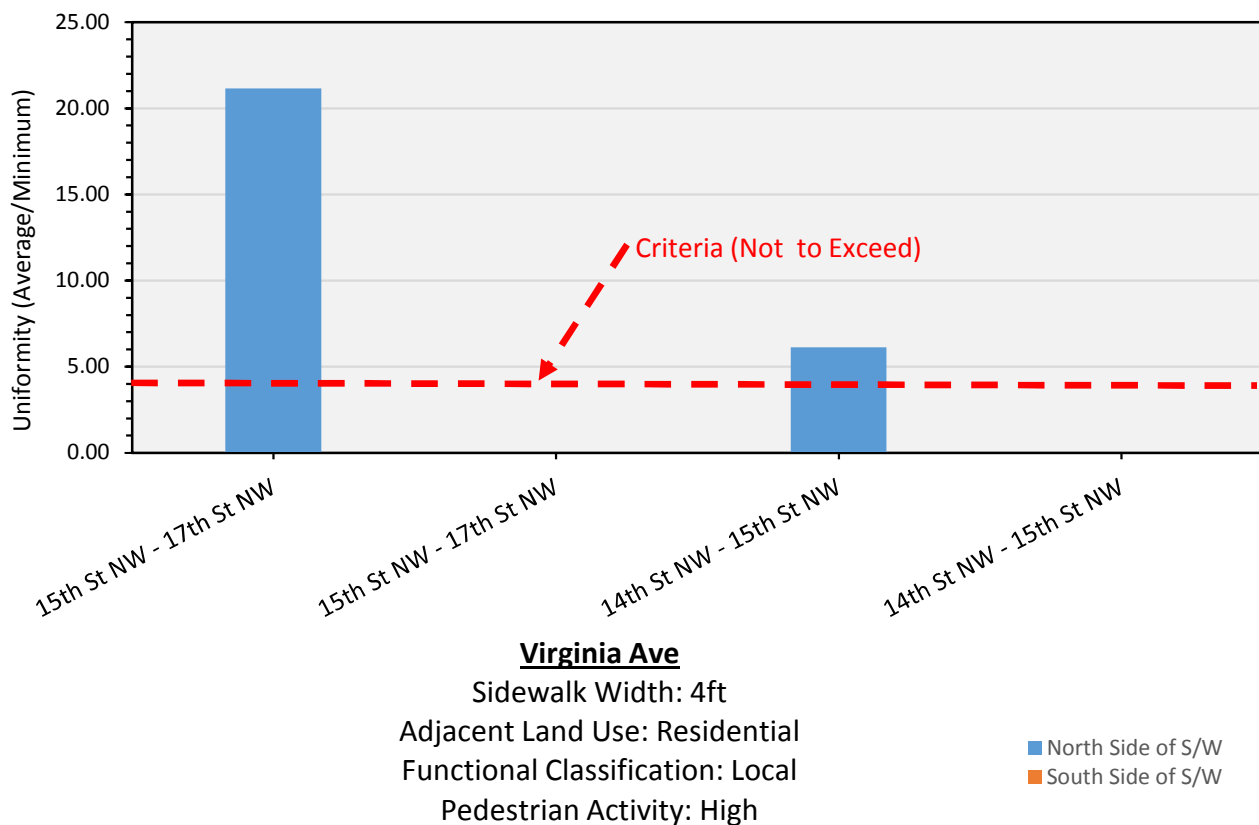
Virginia Ave - Horizontal Uniformity from Existing Lighting

1. Where no bar is shown, average value of 0.00 fc was recorded.
2. Where no bar is shown, uniformity (average/minimum) is not within proposed criteria and cannot be calculated due to 0.00 fc minimum.

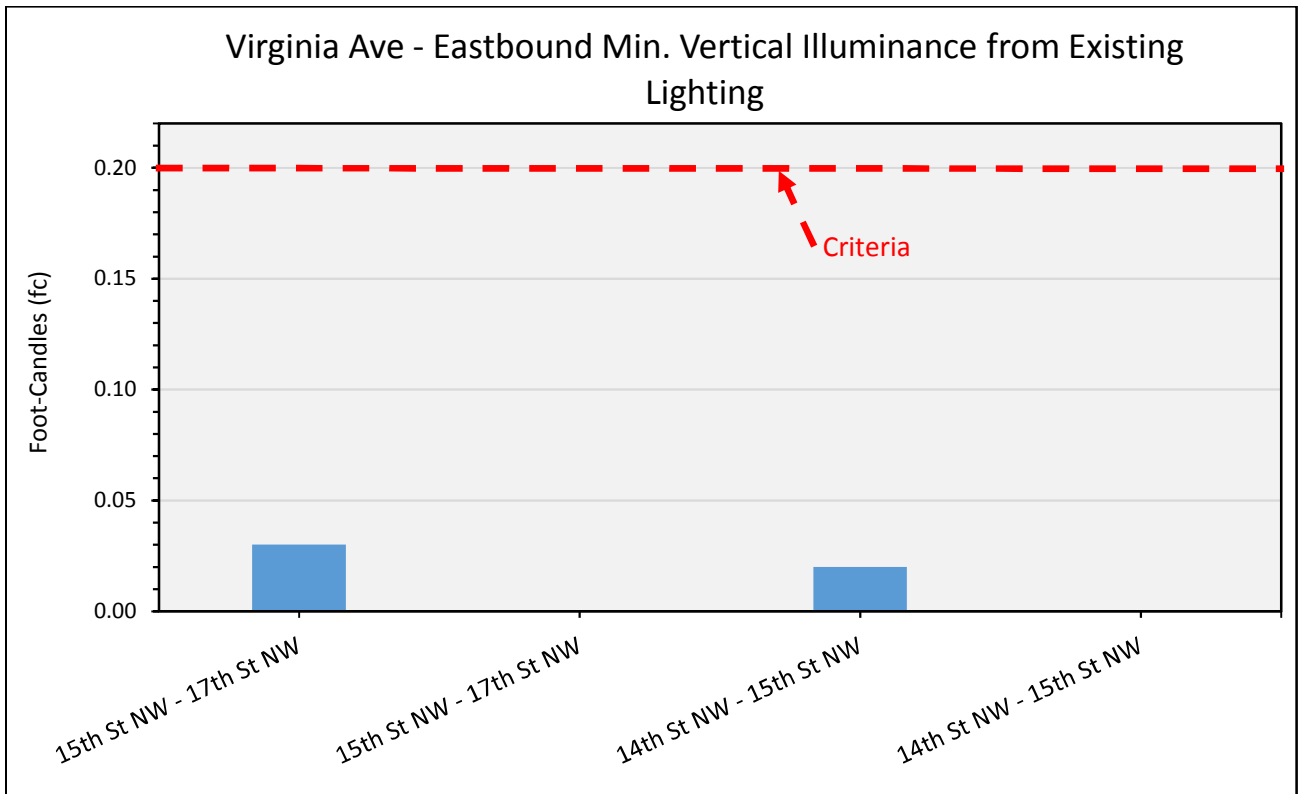
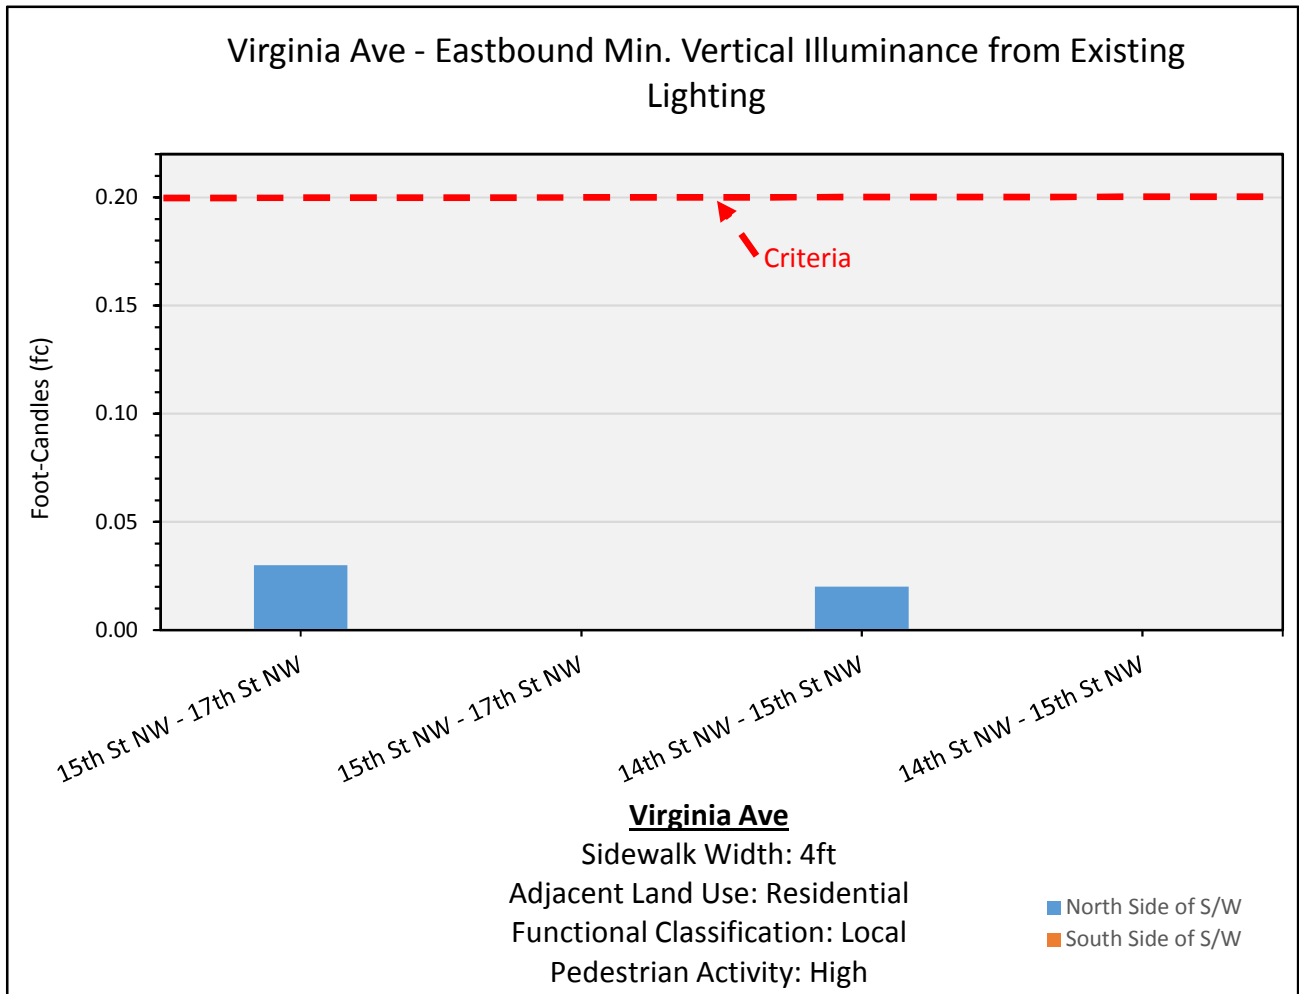
Note:

1. Where no bar is shown, minimum vertical value of 0.00 fc was recorded.

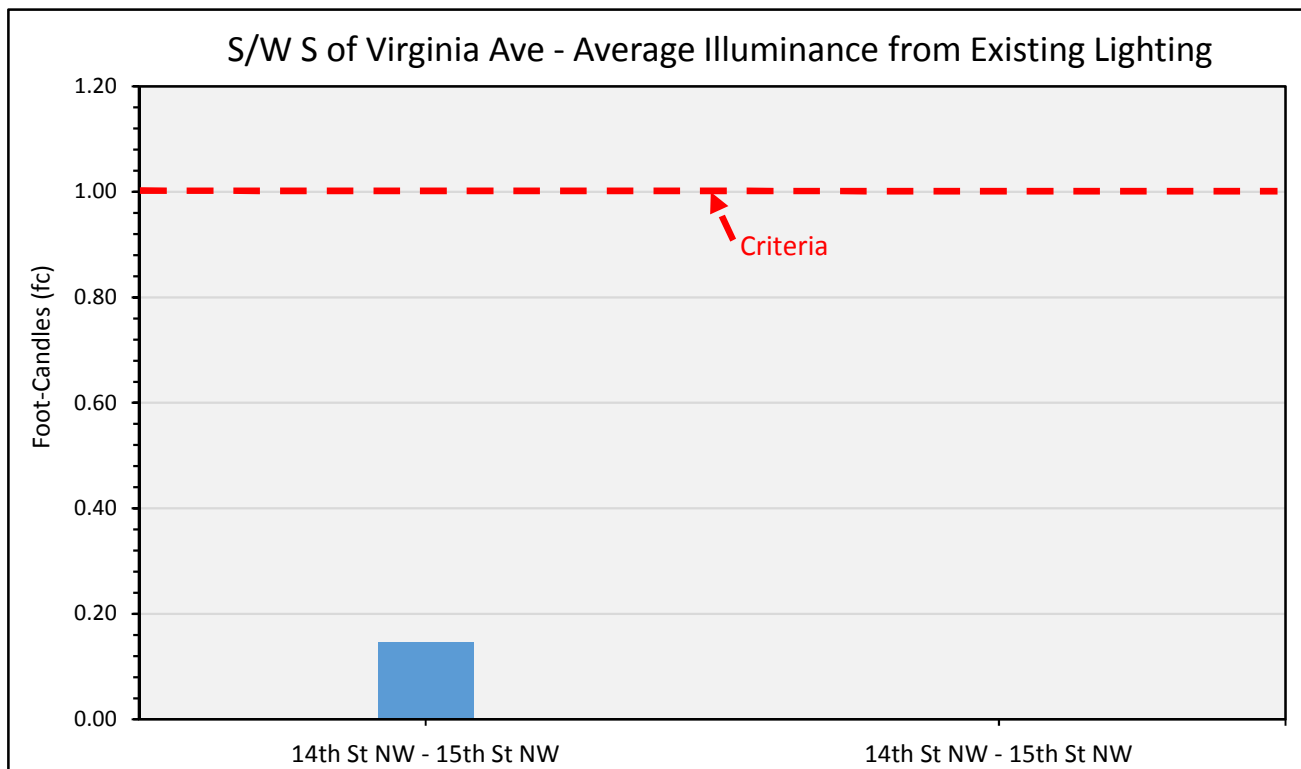
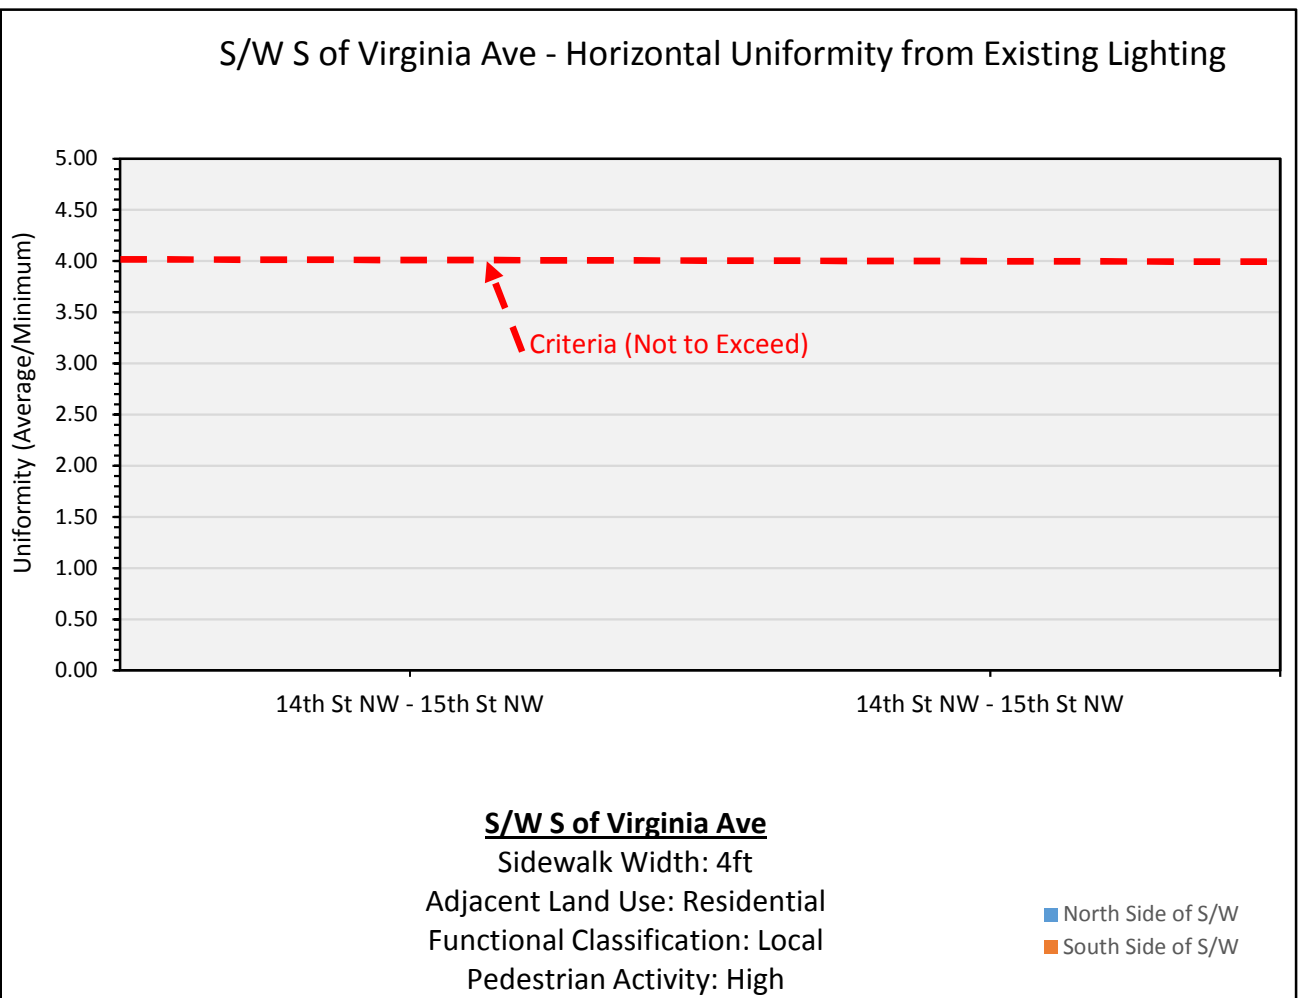
Note:

1. Where no bar is shown, average value of 0.00 fc was recorded.
2. Where no bar is shown, uniformity (average/minimum) is not within proposed criteria and cannot be calculated due to 0.00 fc minimum.

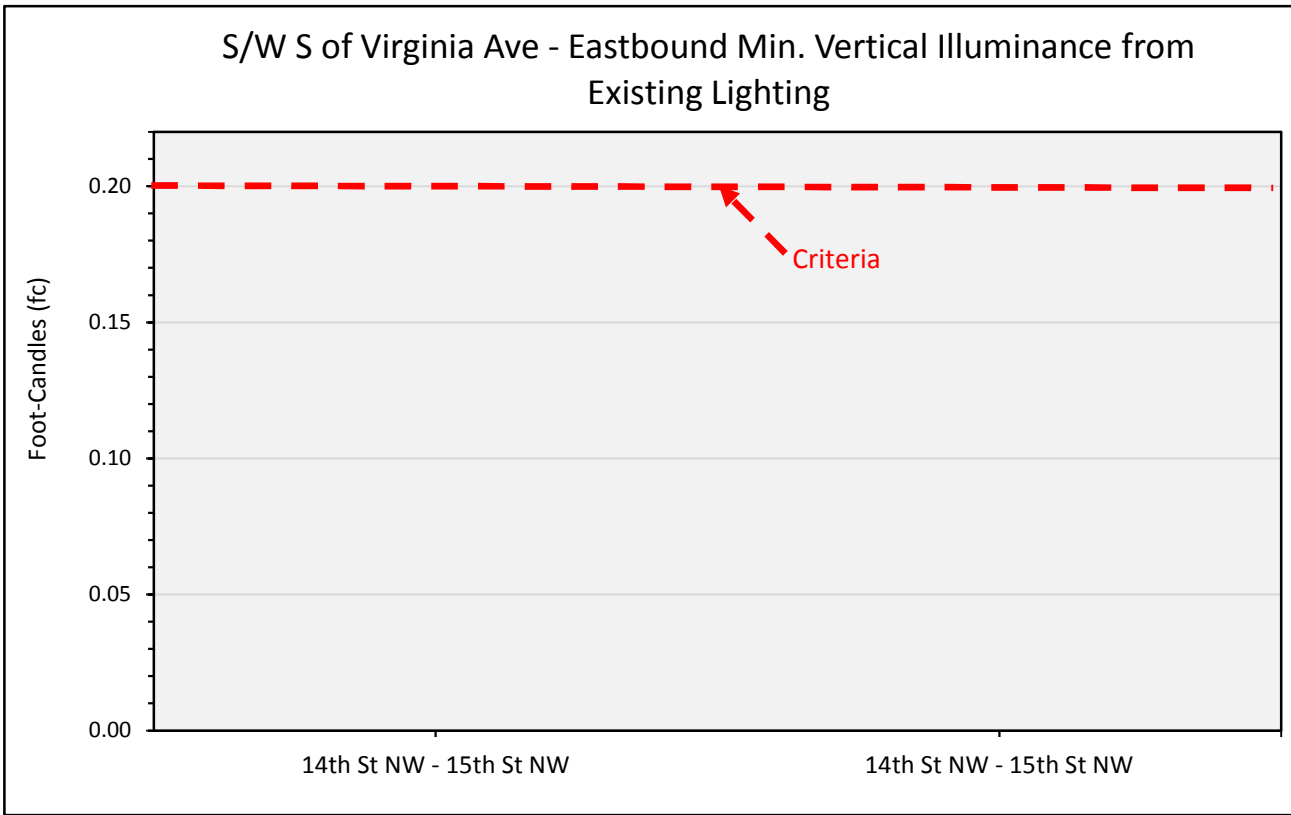
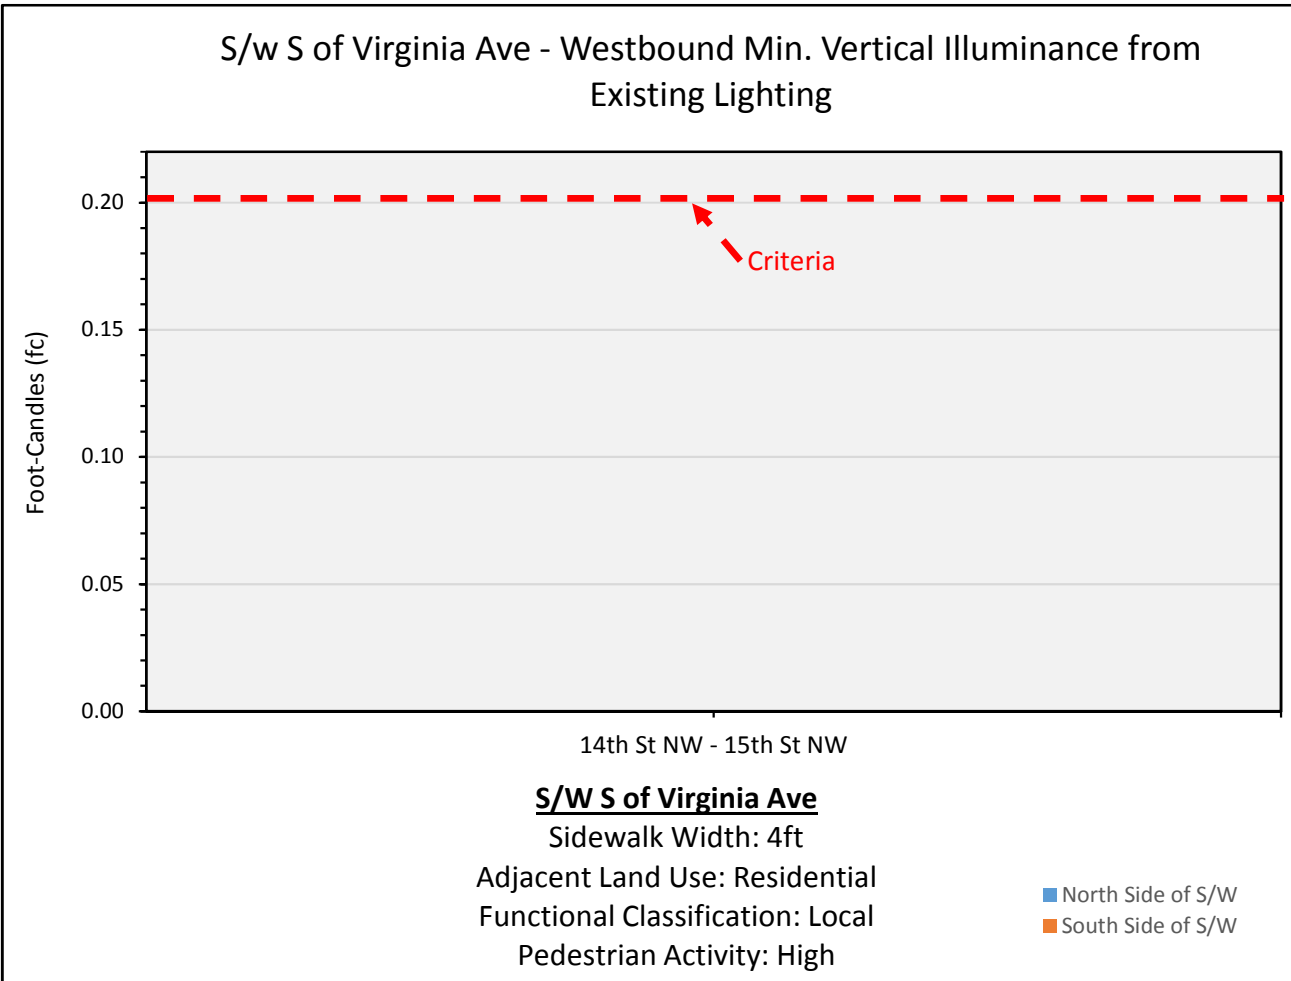
Note:
1. Where no bar is shown, minimum vertical value of 0.00 fc was recorded.

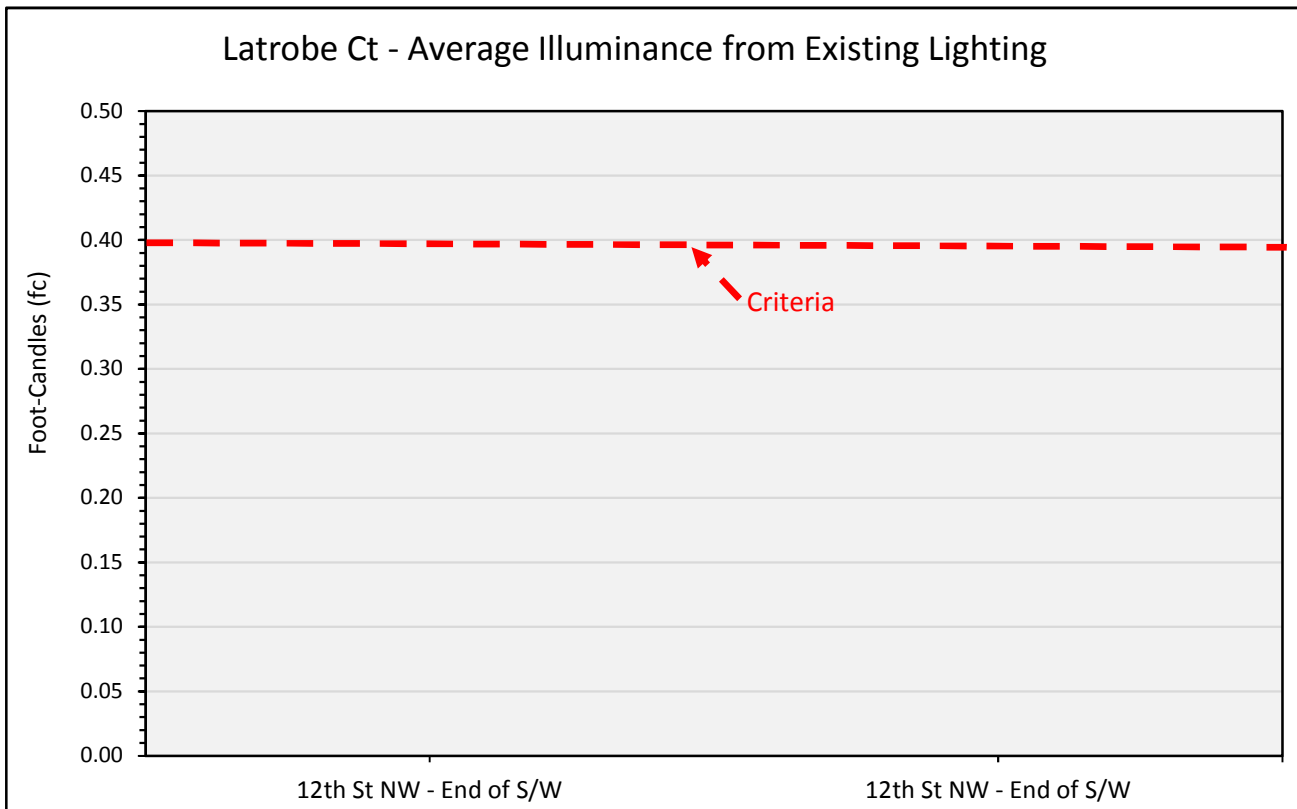
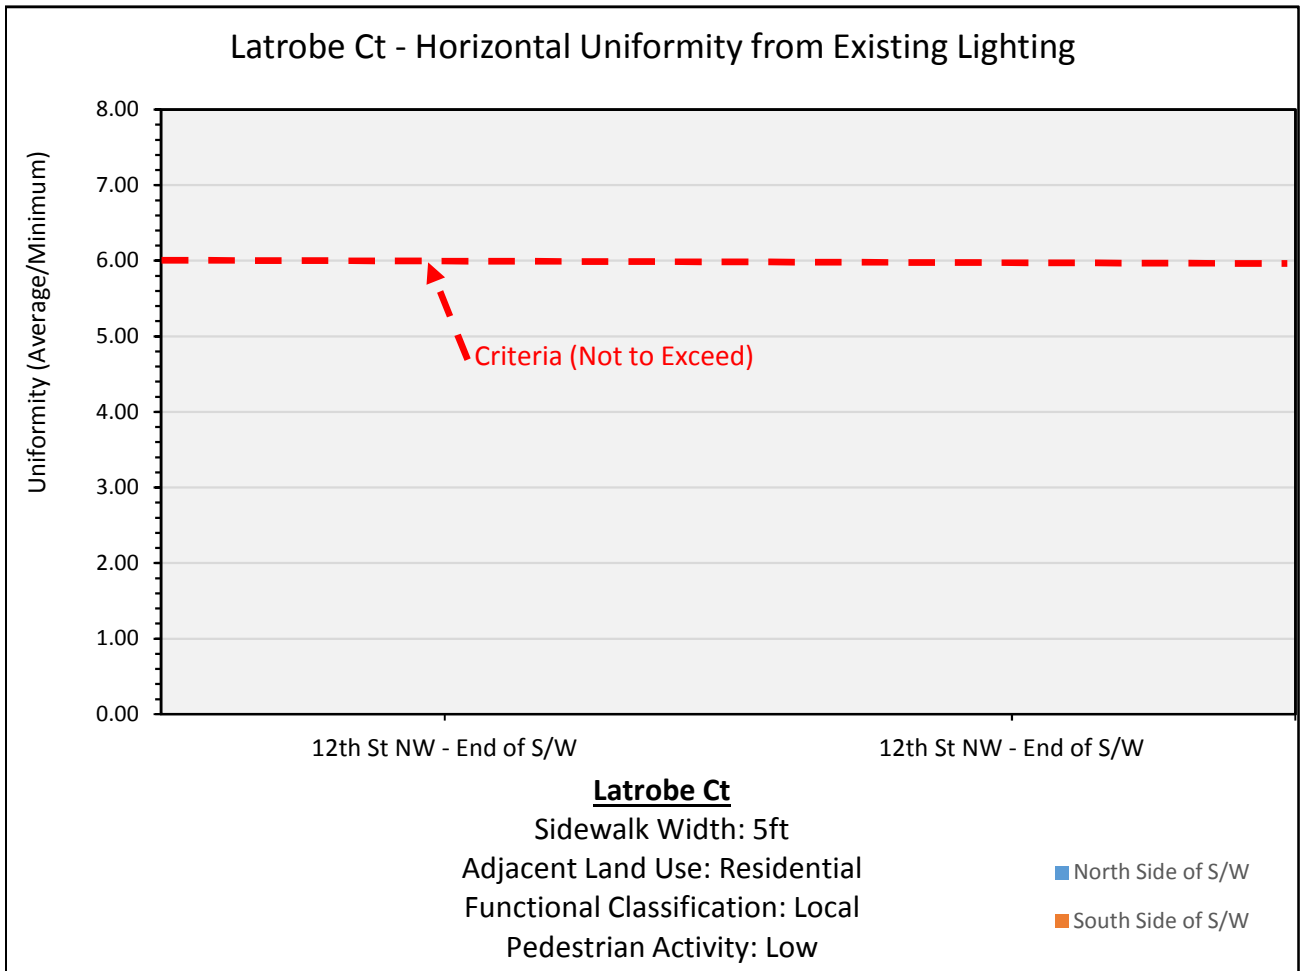
Note:

1. Where no bar is shown, average value of 0.00 fc was recorded.
2. Where no bar is shown, uniformity (average/minimum) is not within proposed criteria and cannot be calculated due to 0.00 fc minimum.

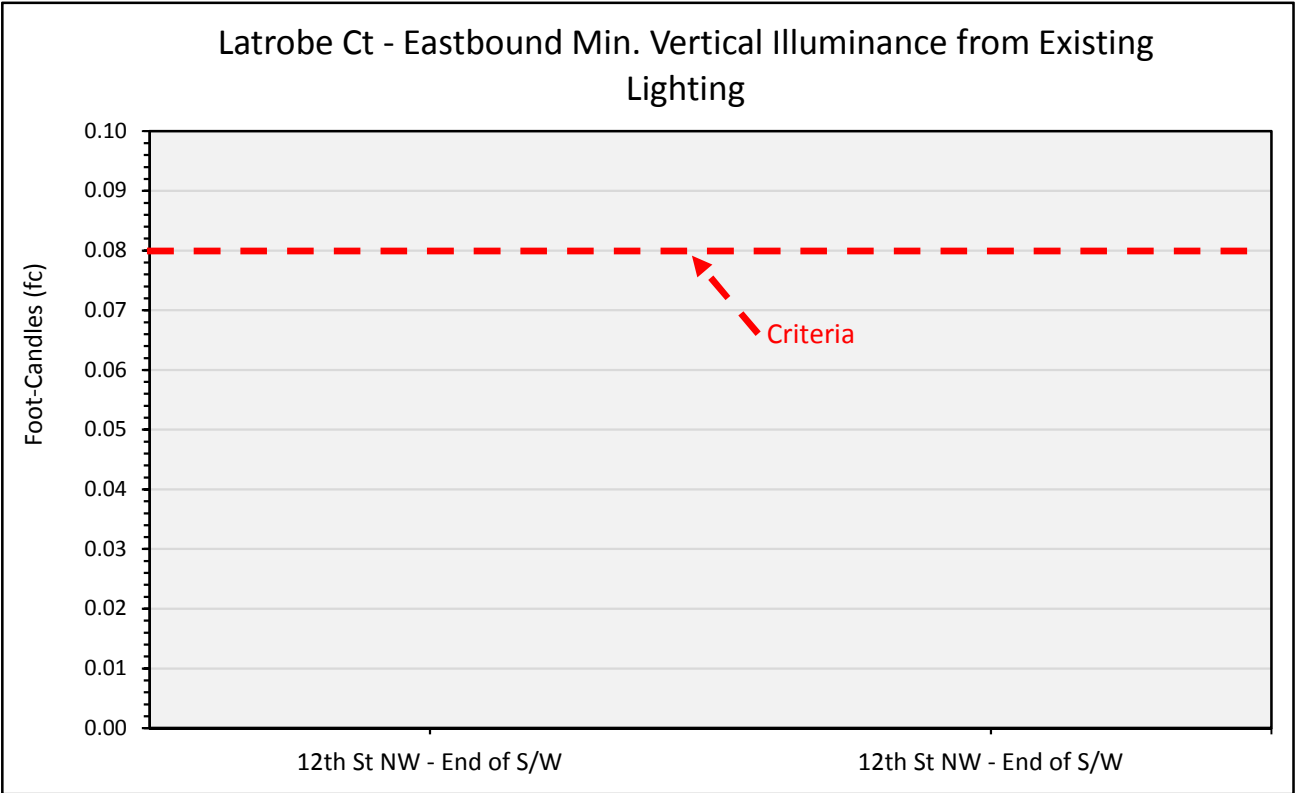
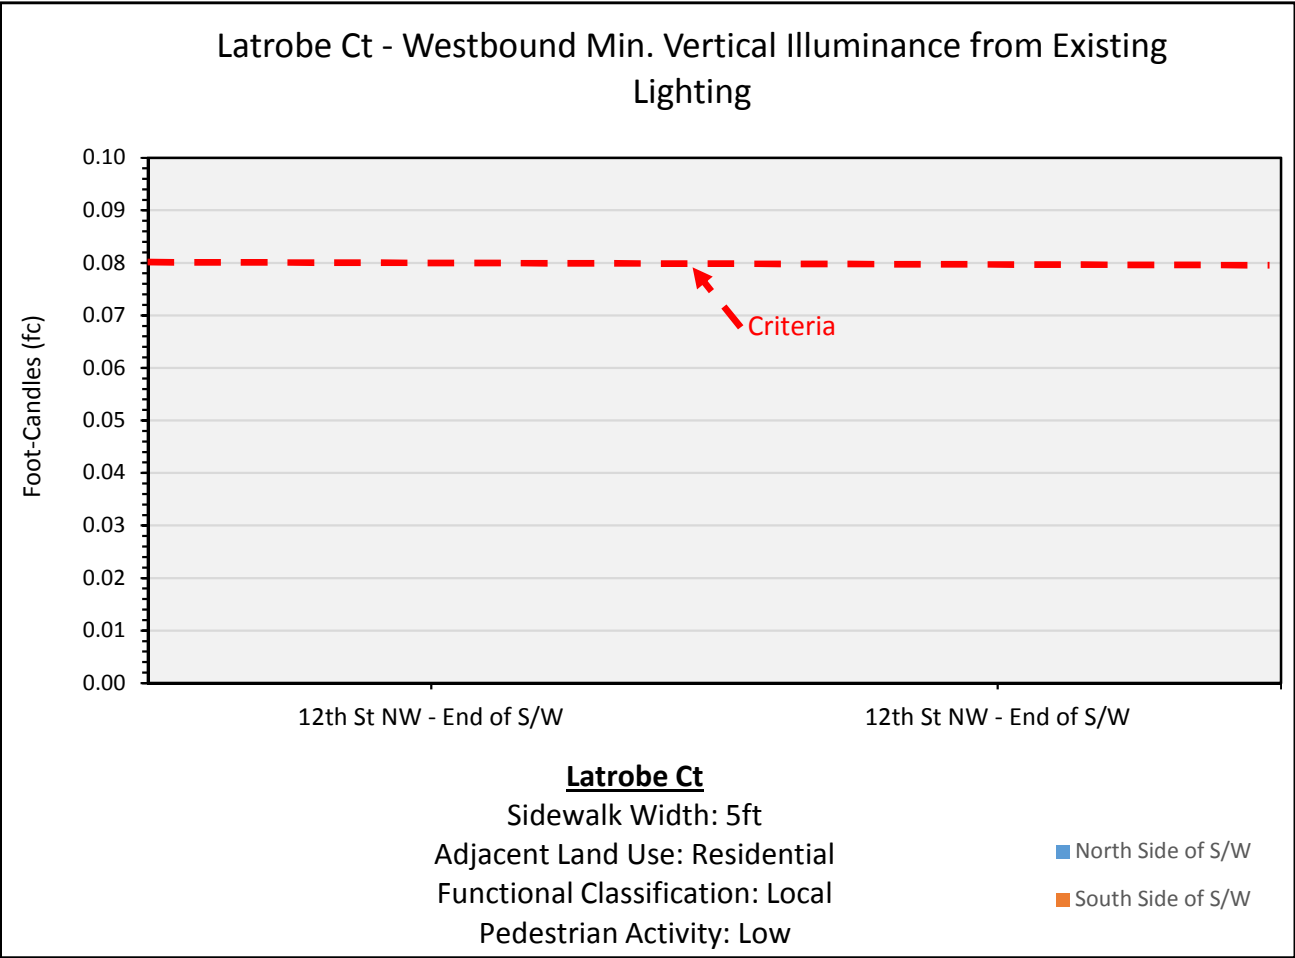
Note:
1. Where no bar is shown, minimum vertical value of 0.00 fc was recorded.

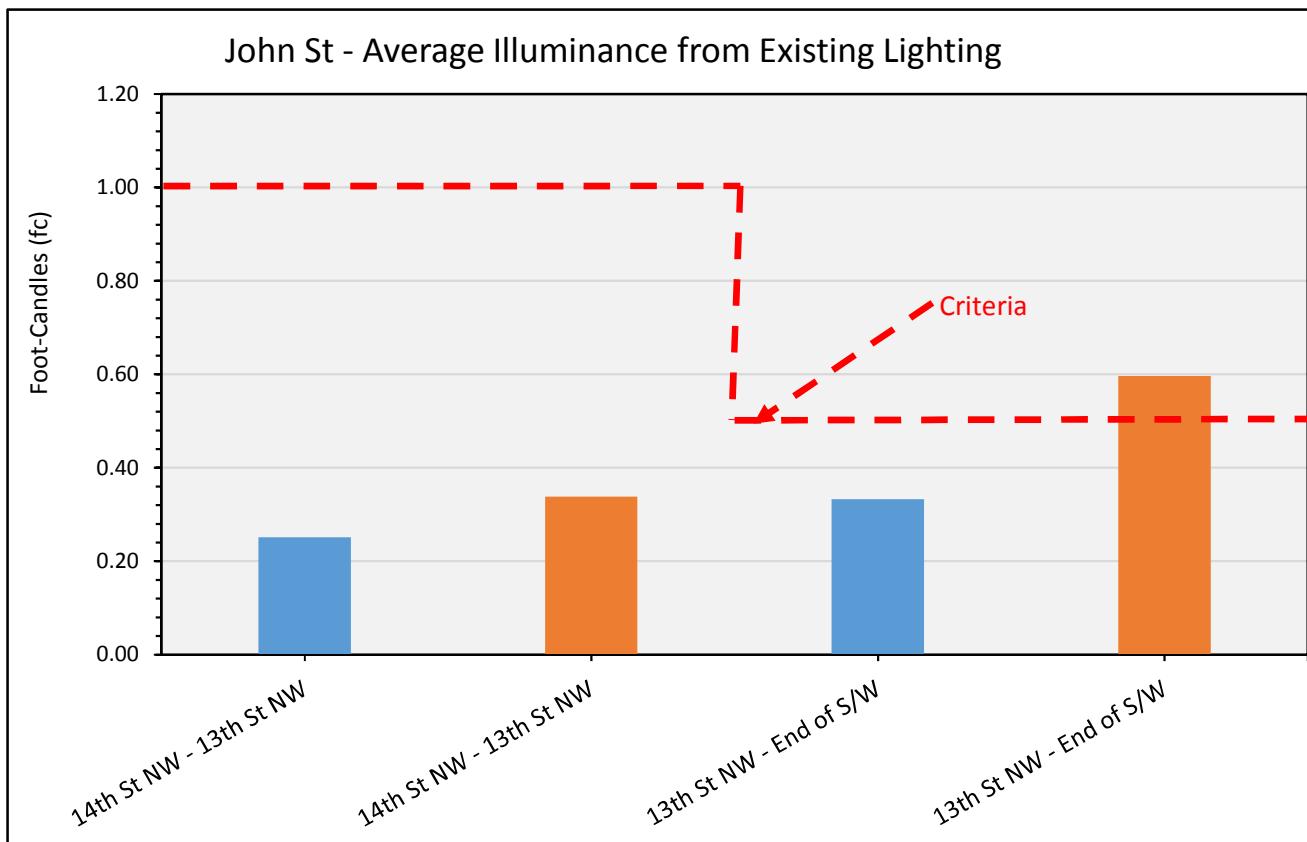
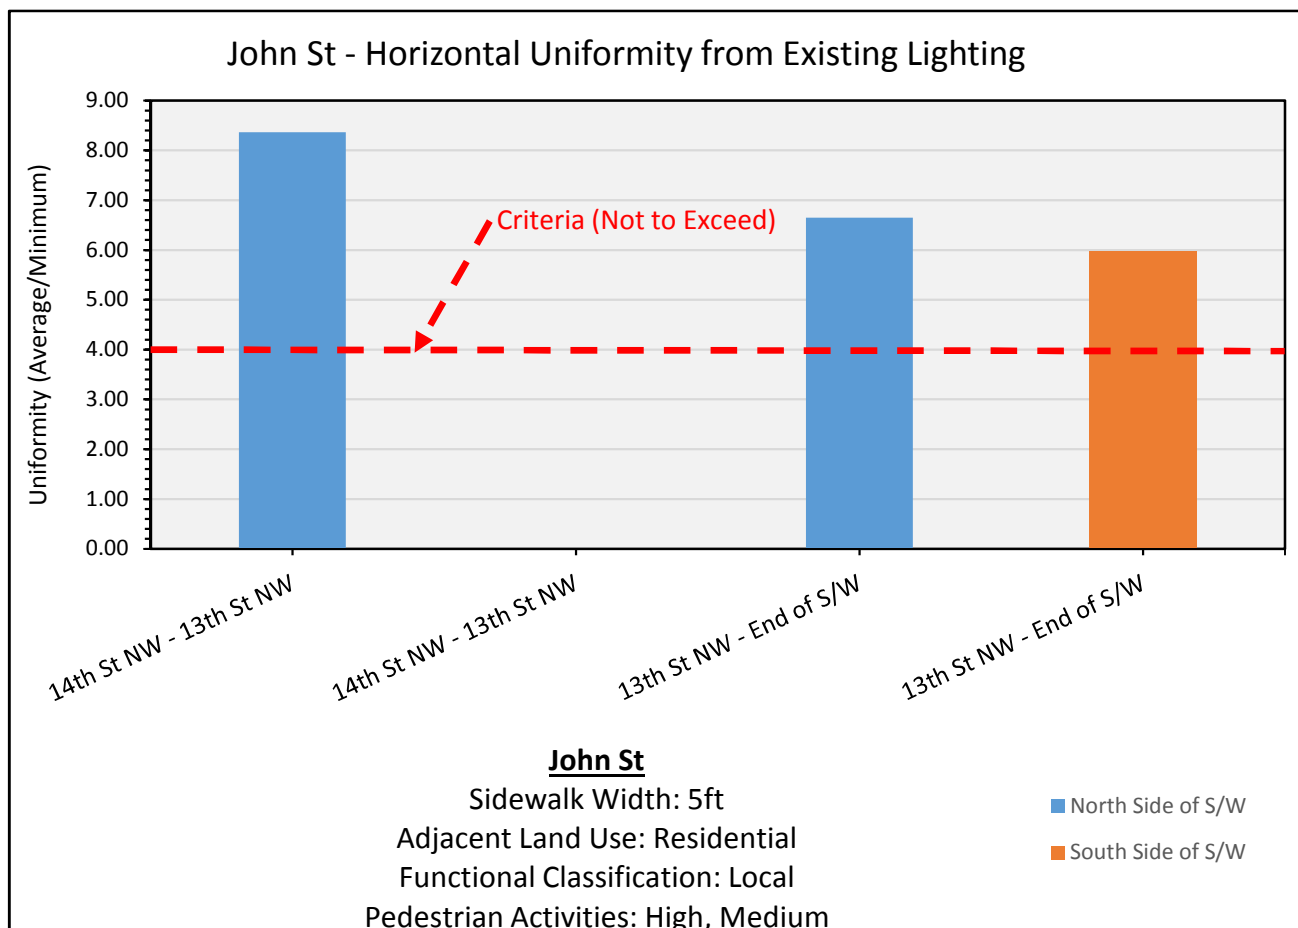
Note:

1. Where no bar is shown, average value of 0.00 fc was recorded.
2. Where no bar is shown, uniformity (average/minimum) is not within proposed criteria and cannot be calculated due to 0.00 fc minimum.

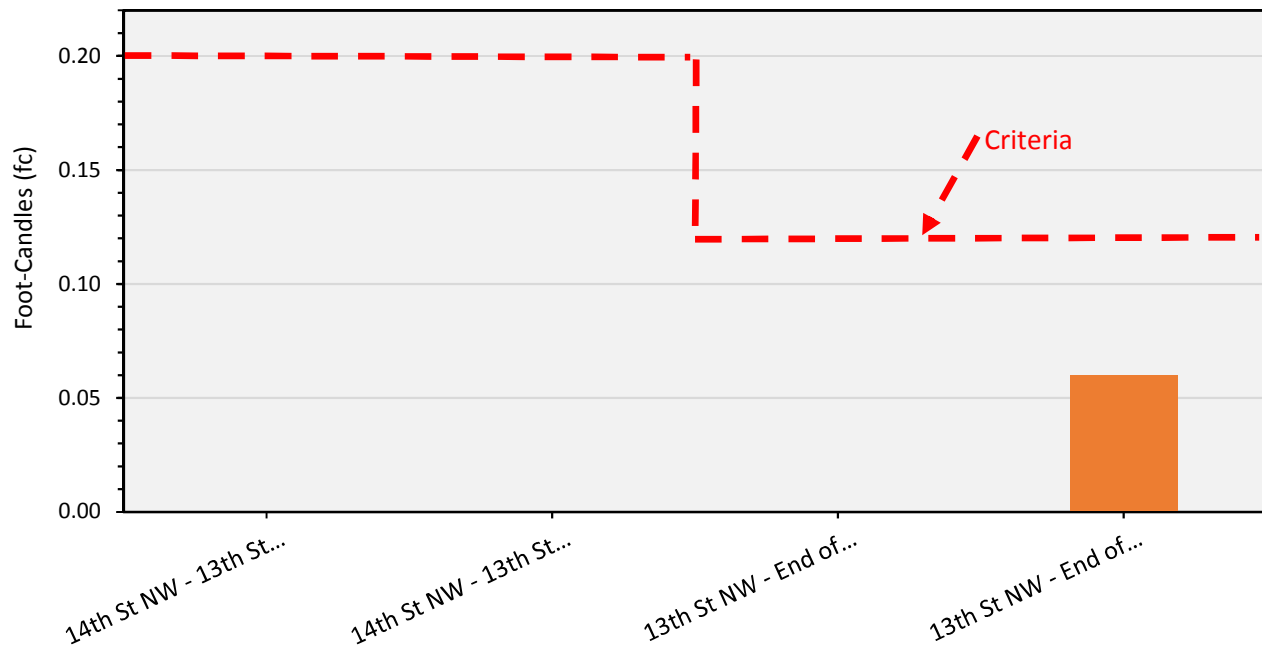
John St - Eastbound Min. Vertical Illuminance from Existing Lighting

John St

Sidewalk Width: 5ft
 Adjacent Land Use: Residential
 Functional Classification: Local
 Pedestrian Activities: High, Medium

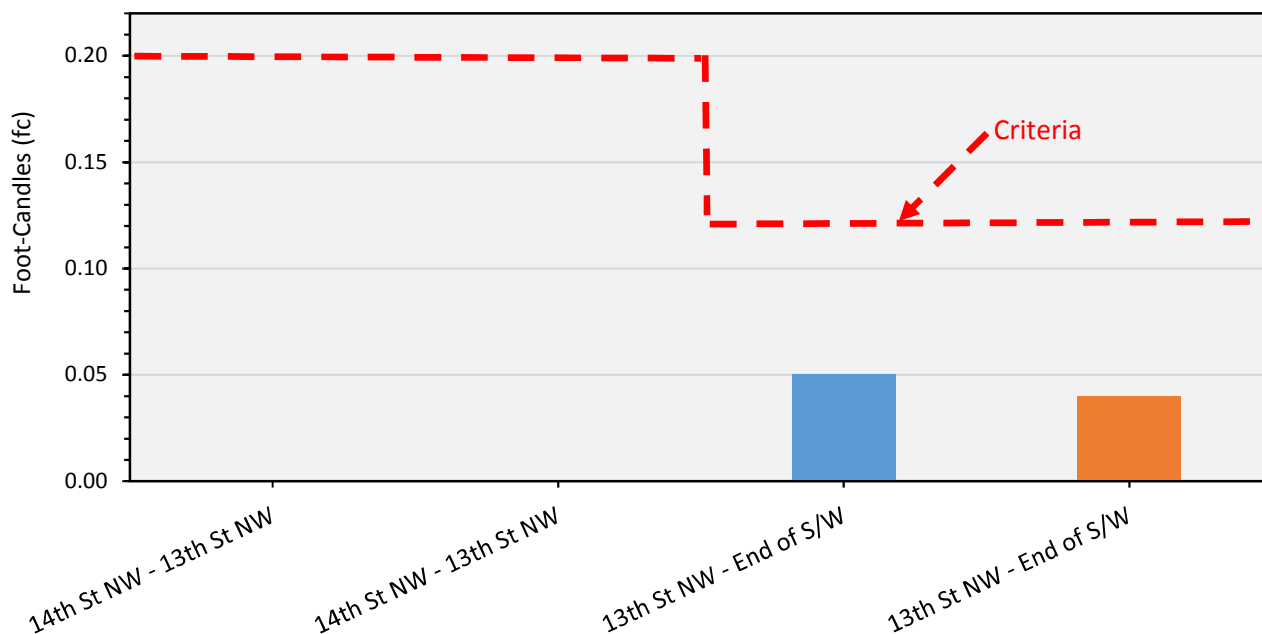
John St - Westbound Min. Vertical Illuminance from Existing Lighting

1. Where no bar is shown, minimum vertical value of 0.00 fc was recorded.

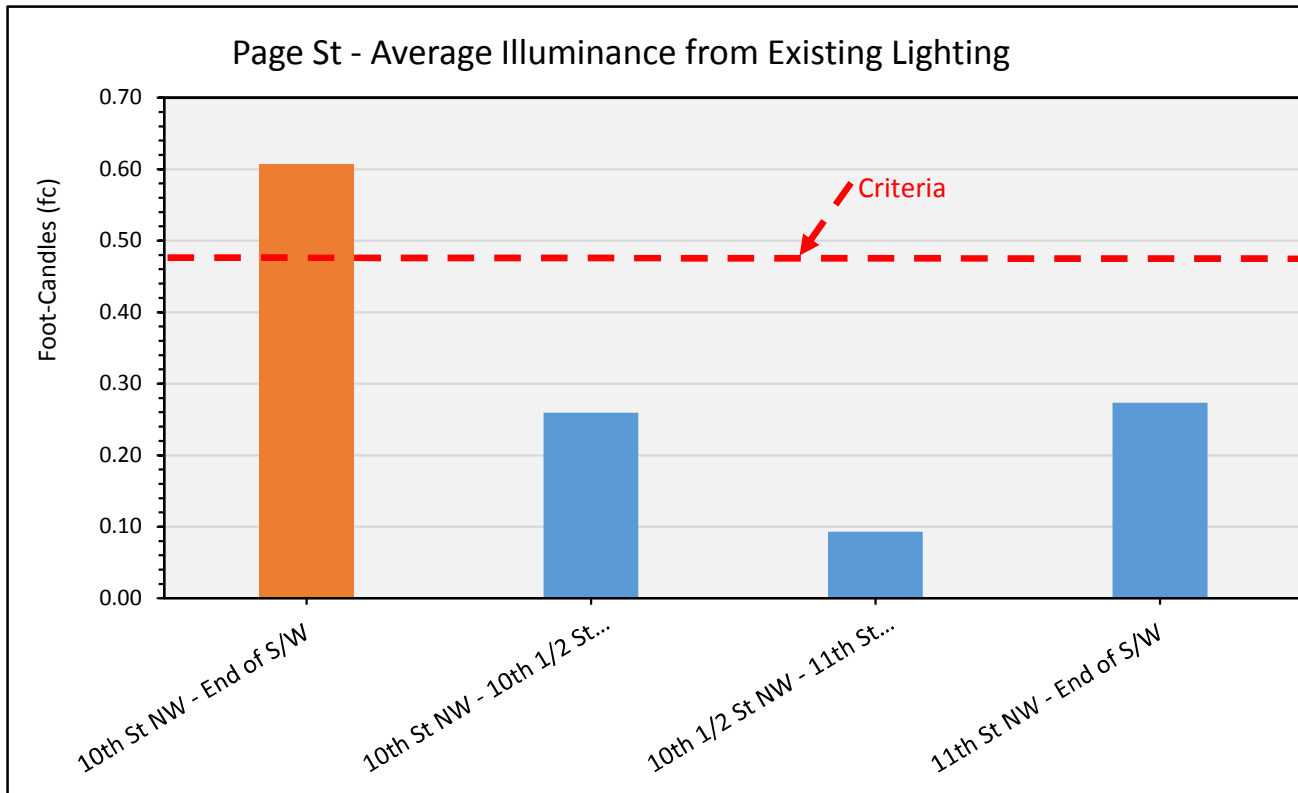
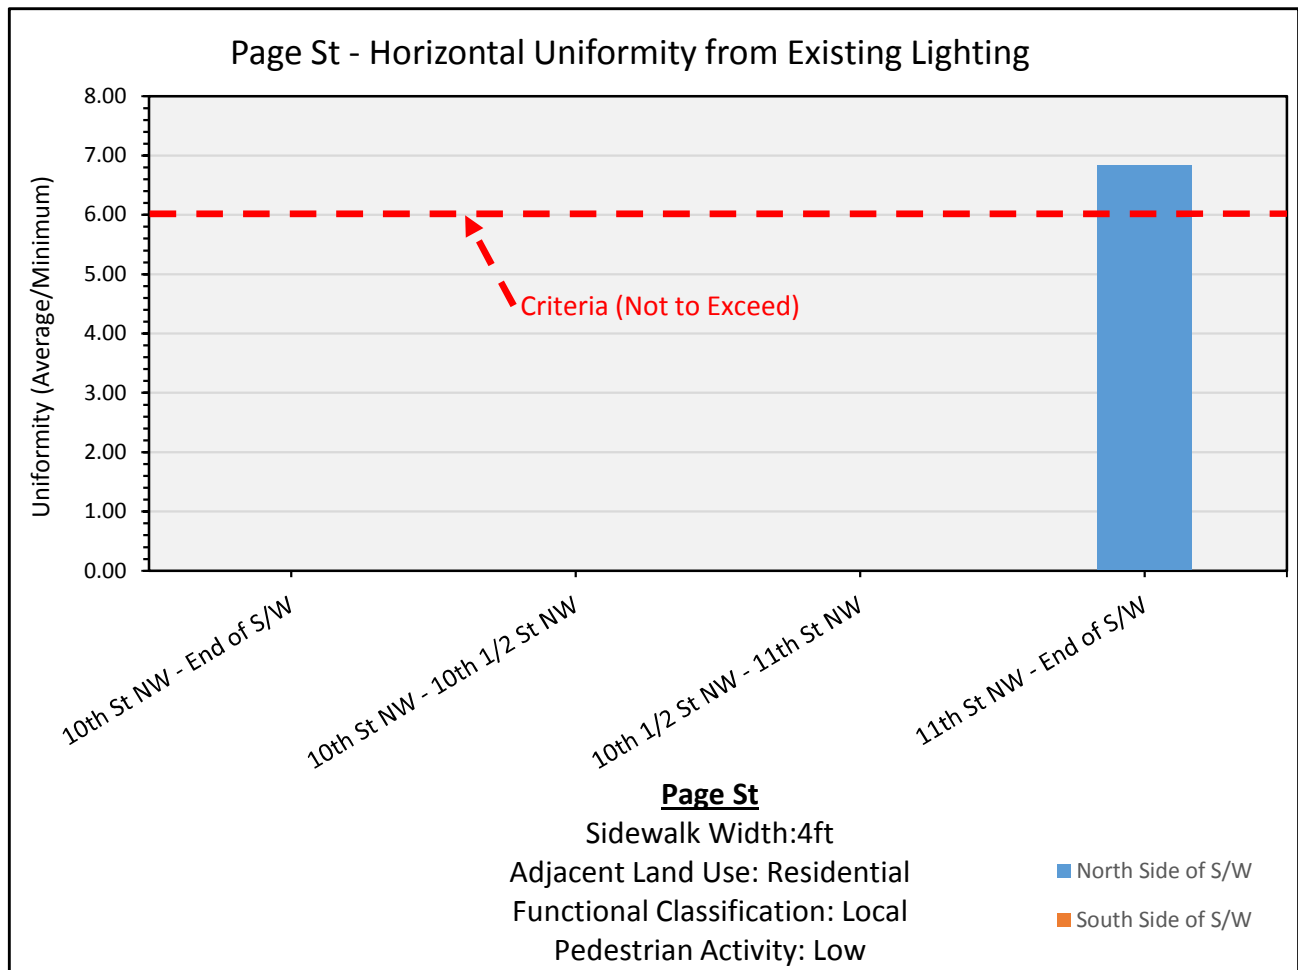
Note:

1. Where no bar is shown, average value of 0.00 fc was recorded.
2. Where no bar is shown, uniformity (average/minimum) is not within proposed criteria and cannot be calculated due to 0.00 fc minimum.

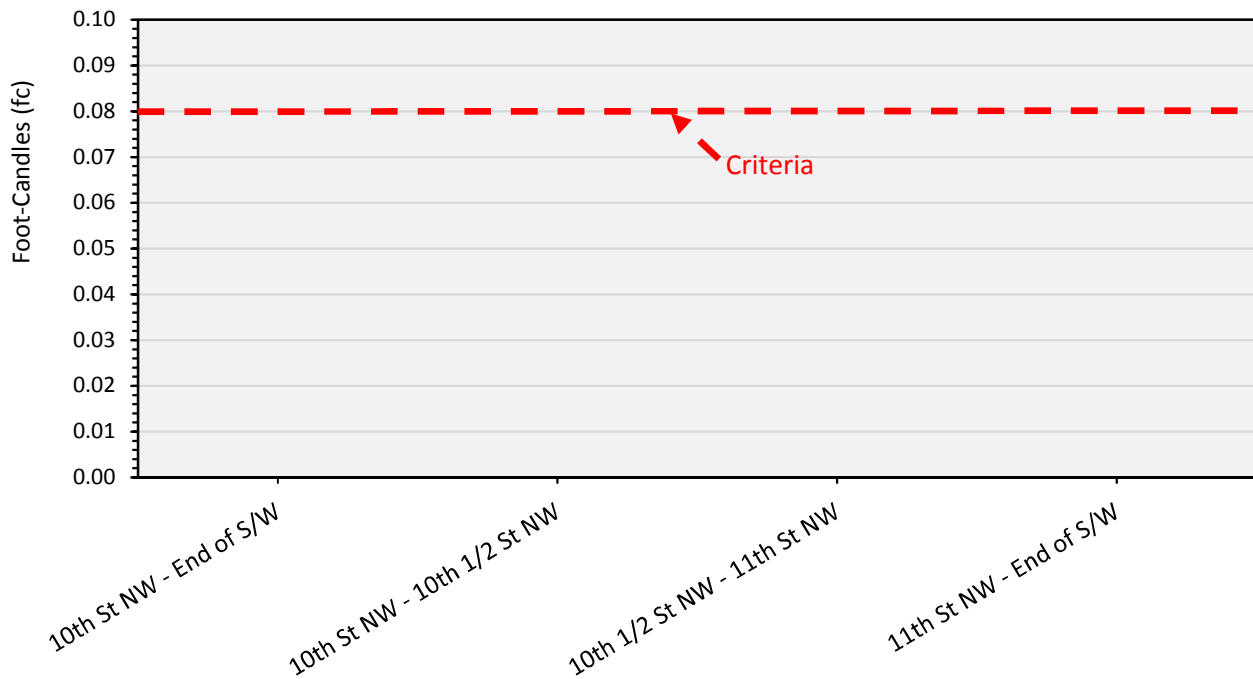
Page St - Eastbound Min. Vertical Illuminance from Existing Lighting

Page St

Sidewalk Width: 4ft

Adjacent Land Use: Residential

Functional Classification: Local

Pedestrian Activity: Low
